# Former Oesing Kitchen Colonial Building in Banyuwangi as Urban Heritage

Banyuwangi Regency is rich in pen-colonial legacy. Colonial remains can still be found in several parts of the city, but quite a few have changed form, even looking different from their original state. One of the buildings is the former Oesing kitchen. The research aims to explore the facade-forming and space-forming elements in the former Oesing Kitchen, Banyuwangi, and the condition of the former Oesing building after restoration. The research method used is qualitative, with data collection techniques through observation, interviews, and documentation. The colonial buildings selected as study cases were carried out using purposive sampling techniques using several criteria. Data analysis was carried out inductively with greater emphasis on historical meaning and value. The results of the observations are a way to explain and conclude the two elements that form the architectural character of these colonial buildings. The research results show that the former Oesing kitchen building has an architectural character that can be determined from the windows, entrance, roof, and walls. Meanwhile, other characters

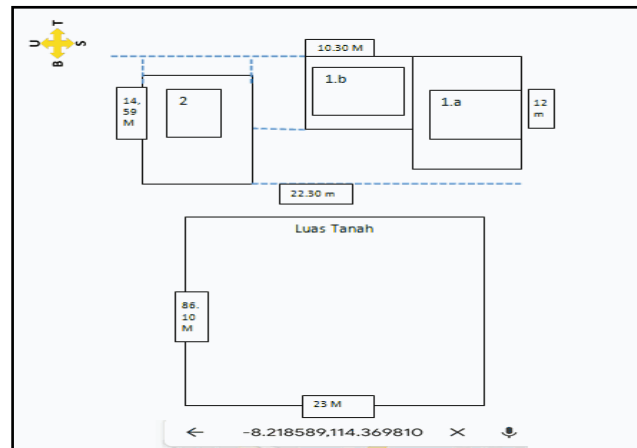
**Figure 1.** Sketch of the Lower Floor of Building 1 and Two Former Oesing Kitchens (Personal Documentation, 2020)

Building 1 consists of 3 parts, namely the living room, main room, and stairs leading to the 2<sup>nd</sup> floor. The divider between the living room and the main room is an entrance door of the same size, namely 150X320 cm, with a square pattern on one side, of which there is a vine motif with iron ventilation as a breeze: wind, no door leaf.

The former Oesing Kitchen Colonial Building has 2 buildings, namely the 1<sup>st</sup> two-story building (main building) to the south and the building to the North. The two are separated by a hallway/aisle as a barrier (Rachmah et al., 2022; Warjiyati et al., 2023). In the living room and main room, there are 26 doors, but they do not have doors. The size of each door leaf is different. It was not known for certain before the Oesing kitchen manager used it whether this building was closed or had many doors. Door 1, from the front, measuring 150. Door 2, from the front, measuring 130x320 cm, no door leaf. Door 3, from the north side, with dimensions 194x245 cm, no door leaf. Door 4, from the north side, measuring 320. Door 5, from the north side, measuring 110x220 cm, no door. Door 6 is in the middle of the building, and its dimensions are 125x235 cm. There is no door. Door 7, located in the middle of the building, measuring 150x320 cm, has a curved pattern on one side. There is a vine motif with iron ventilation for air. Door 8 is in the middle of the building with dimensions 130x320 cm. Door 9 is on the south side with dimensions 110x320 cm; no door. Door 10 is on the south side with dimensions 160x320 cm; no door. Door 11 is on the south side with dimensions 160x320 cm; no door. Door 12, from the south side, measuring 153x203 cm, has no door leaf. Door 13, from the south side, with dimensions 150x203 cm, no door leaf. Door 14, from the south side, with dimensions 124x203 cm, no door leaf. Door 15, rear east side, measuring 125x250 cm, has a rectangular pattern with a perforated curved motif for the winds. there is no door leaf. Door 16, back east, with dimensions 188. Door 17, back east, measuring 125. Door 18, back east, measuring 120x213 cm, no door leaf. Door 19, back east, measuring 116x213 cm, no door. Door 20, back east, measuring 116x213 cm, no door leaf. Door 21, back east, measuring 116x213 cm, has a door leaf without motifs and ventilation holes.

In the Staircase, based on the building plan, there are 4 doors and 1 window. The information is as follows. Door 22, with dimensions 117x213 cm, has a door as a middle divider on the 2<sup>nd</sup> floor/stairs. Door 23, on the west side, with dimensions 130x215 cm, no door leaf. Door 24, on the east side, with dimensions 103x210 cm, no door leaf. Door 25, on the east side, with dimensions 232x233 cm, no door leaf. Window 26, measuring 125x109 cm, middle divider leading to the 2<sup>nd</sup> floor/stairs. Second, ladder. The stairs are made of wood. It consists of 3 levels, namely lower, middle, and upper. There is a banister.

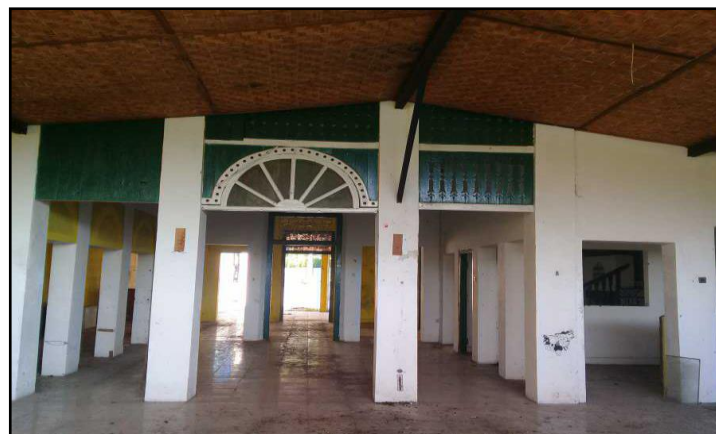
**Figure 2.** Sketch Showing Many Doors (Personal Documentation, 2020)

Based on the south building, the 1<sup>st</sup> floor of the building is still intact, but the doors are missing. In this area, you can see a number of new additional components, such as sinks and dishwashers, including the guardrail in the hallway between buildings 1 and 2. The floor has been replaced. The roof structure of the rear 1<sup>st</sup> floor has added new components, apparently to support the function of this building as a restaurant. a) Colonial Building 2<sup>nd</sup> Floor (south), (b) Building 2 (North) without front showed in Figure 3. Building 2 (North) side view showed in Figure 4. The second building has changed or has been renovated with a new facade, either due to changes in shape or material or because of the addition of a new function.

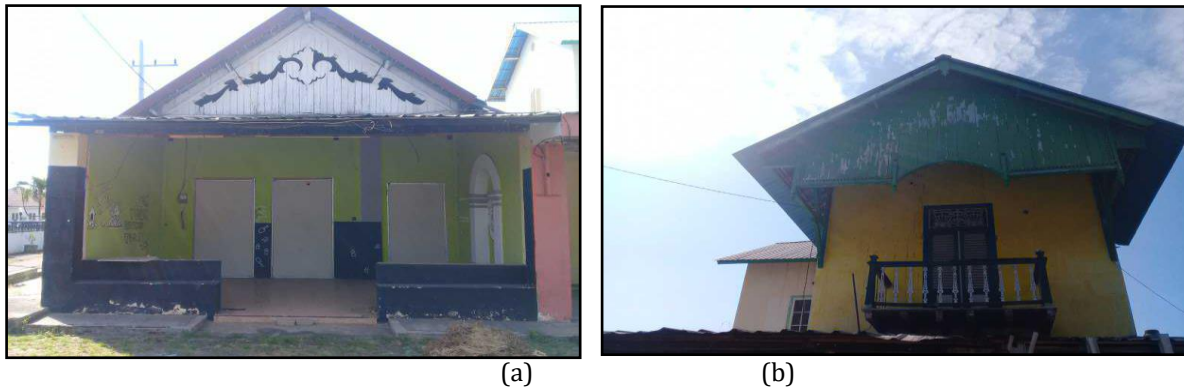
**Figure 3.** (a) Colonial Building 2<sup>nd</sup> Floor (South), (b) Building 2 (North) Without Front (Personal Documentation, 2020)

The steps measure 1.5 m and are 60.9 m high. There are 21 steps. There are 2 stair doors, namely in the middle and top positions. Third, 2<sup>nd</sup> Floor Building. The 2<sup>nd</sup>-floor building is on the same plan as building 1, and it has the same area and shape. The balcony measures 315x160 cm high with a tendril motif. There is 1 main door with ventilation motifs or breezes with geometric patterned vines measuring 215/90 cm. There is a door leaf. Curved roof with no motif. Basic 2<sup>nd</sup> floor with wooden floor. Six windows are the same size, 240x135 cm, and the shutters are 65x240 cm. There is also a pair of double doors made of glass and wooden blinds. He is above the door next to the arch. There are 3 corridor doors. Based on the 2<sup>nd</sup> floor building, as follows: The condition of the 2<sup>nd</sup> floor is intact, including walls, floors, windows, and doors. Characteristic of the colonial era with thick walls and towering windows and doors. This is done to accommodate the circulation of cool air entering the room. The 2<sup>nd</sup> floor is made of teak wood, the same as the British cultural heritage buildings. Intact doors and windows can be a reference for restoring the condition of incomplete doors and windows on the first floor. The previous management most likely replaced the roof of the 2<sup>nd</sup>-floor building because it was made of zinc/aluminum/galpalum.

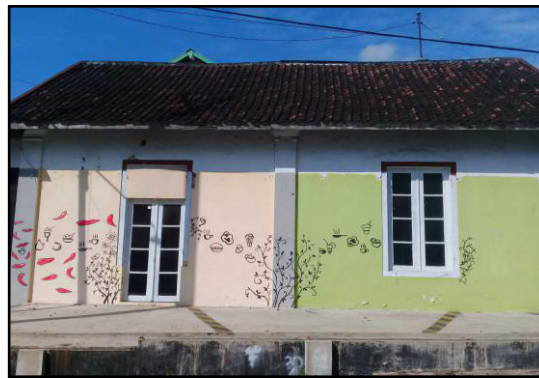
**Figure 4.** Building 2 (North) Side View (Personal Documentation, 2020)

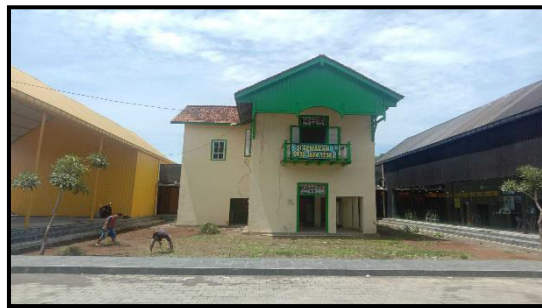
North Building, Former Osing Kitchen. The plan of building 2 is rectangular with dimensions of 14.59 m x 9.22 m. There is a new building from the main building. There are 2 doors on the north side with the same size, namely 140x240 cm. However, the shape of the first door has been changed. There are 2 doors on the north side with the same size, namely 140x240 cm. However, the shape of the first door has been changed. Condition of the building after restoration. The following is the condition of the former Oesing Kitchen building after restoration (Lopesi, 2024; Suwitra et al., 2023). From the picture above, there is a difference, namely that the building to the North was restored to the ground and replaced with a new building. Likewise, the middle building is still maintained, but on the back and right side, there is a new building. Differences between buildings on the north side after being restored to the ground. New superstructure and old substructure showed in Figure 5.

**Figure 5.** Differences Between Buildings On The North Side After Being Restored To The Ground. New Superstructure And Old Substructure (Personal Documentation, 2023)
